Manhole Inspection Summary

Manhole # S35M__011MH

Insp Date: **3/25/08 11:06 AM**

Location Address: **7 e. lee**

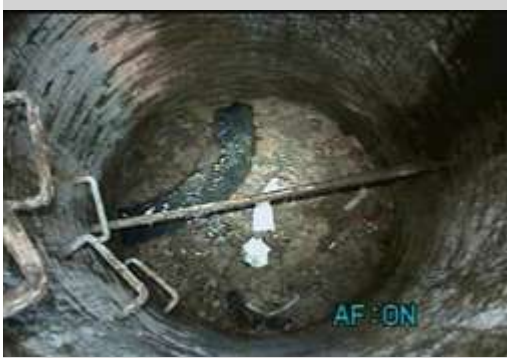
misc

rod stuck between 3 and 9

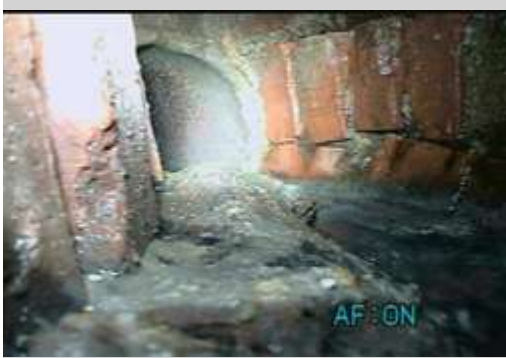
misc

Condition: ☒ Sound ☐ Cracked ☐ Root Intrusion ☐ Deteriorated ☐ Leaks ☐ Debris

Channel debris

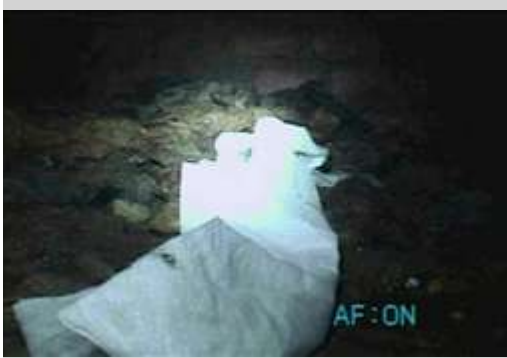
Defect 4

Condition: ☐ Sound ☐ Cracked ☐ Root Intrusion ☐ Deteriorated ☐ Leaks ☒ **Debris**

bench debris

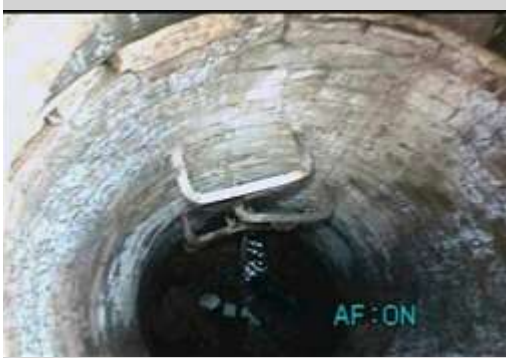
Defect 3

Steps Count: **7** Missing: **0** ☒ **Corroded**

steps

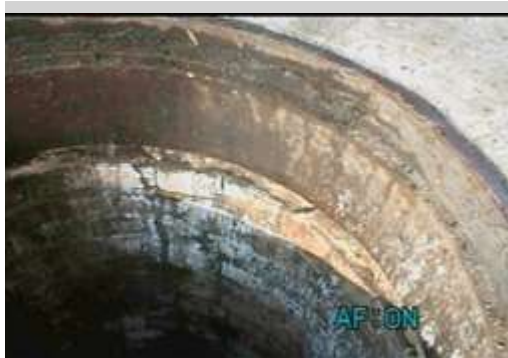
Defect 2

Condition: ☐ Sound ☒ **Cracked** ☐ Root Intrusion ☐ Loose Brick ☒ **Deteriorated**

chimney cracked

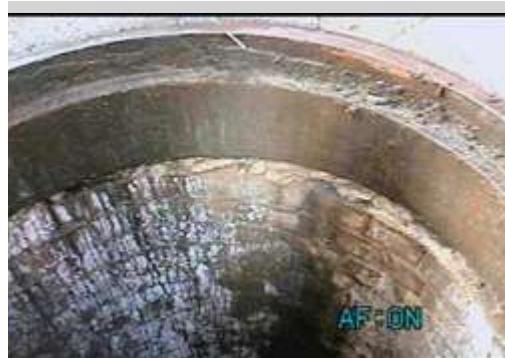
Defect 1

Chimney / Frame Adjustment ☒ Exists Material: **Concrete** ☐ Parged Height: **2** (in.)

Chimney deteriorated, frame adjustment
